CJC™ Application Study

Energyworks Valladolid - Iberdrola, Spain.
Cogeneration, combined cycle power plant inside Michelin tire factory.

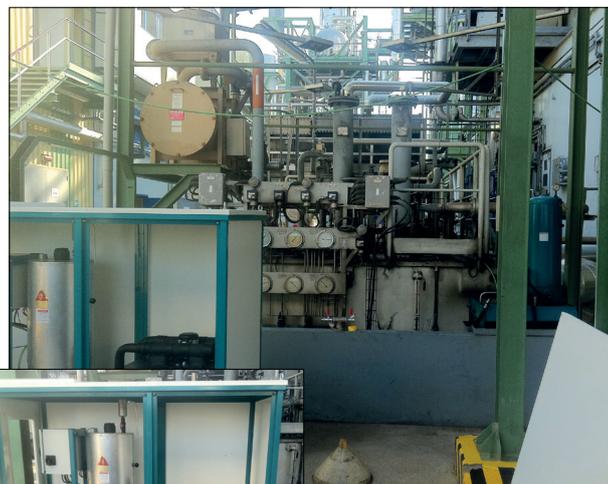
The CJC™ Varnish Removal Unit, VRU installed at Energyworks Valladolid, Iberdrola, Spain

We decided to install the CJC™ Varnish Removal Unit, VRU with CJC™ Varnish Removal inserts, VRi to remove varnish and lower the MPC value to below 15. The CJC™ VRU draws the oil from the bottom of the reservoir, filters out varnish and returns the clean oil to the top.

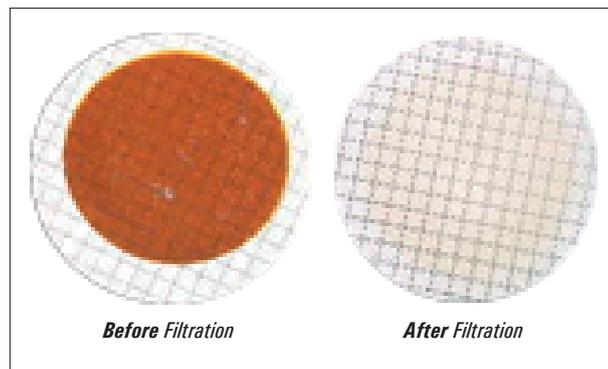
MEMBRANE PATCHES (MPC)

Before Filtration, June 4, 2012	After Filtration, June 18, 2012
ISO Code	17/15/12	16/14/12
MPC value (ΔE)	42	8

At the start up of the CJC™ VRU, the oil sample showed an ISO code 17/15/12 and an MPC value of 42. After two weeks of filtration the analysis results are the following: **ISO code 16/14/11 and an MPC value of 8**. These results are optimum for the turbine performance and oil maintenance.
